Announced Premises Inspection Report 24 October 2016

Alpine House

Type of service: Residential Care Home
Address: 20 Ballyholme Road, Bangor, BT20 5JN
Tel No: 028 9145 4904
Inspector: Gavin Doherty

The inspection was undertaken to assess the facts surrounding, and the damage caused to the premises in a recent fire which happened on 21 October 2016 at 08:45.

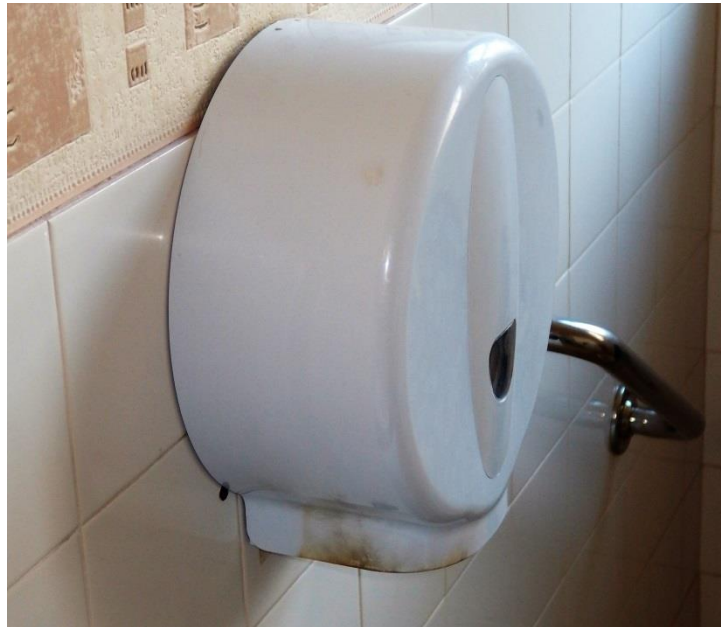
The Registered Manager explained that the fire alarm first sounded at approximately 08:20. Staff responded immediately to this and checked Fire Zone 2, which was highlighted by the fire alarm panel. Staff discovered no signs of fire but did discover some burnt toilet paper and minor scorch damage to a toilet roll dispenser in the first floor Bathroom which is adjacent to Bedroom 1. The alarm was reset and staff resumed their normal duties. The fire alarm sounded again at approximately 08:45 and again highlighted Zone 2. Staff again responded to the alarm and began checking zone 2. The smell of smoke was immediately noted coming from Bedroom 1 and staff immediately called the fire service and started evacuating residents from this bedroom sub-compartment. At this time there was only one resident within the sub-compartment in Bedroom 3 and he was accompanied down the stairs by staff. The Home's emergency contingency plan was then put into action and all residents were relocated to Bayview Resource Centre.

Scorch Damage to toilet roll dispenser in first floor bathroom

After the first activation of the alarm when the burnt piece of toilet paper was discovered in the bathroom, it would have been prudent of staff to check on the two residents who are known to be smokers in the home. The origin of the fire was in Bedroom 1 which is adjacent to this bathroom, and is occupied by a resident who smokes.
