Unannounced Infection Prevention/Hygiene Inspection

Ballymena Ambulance Station
Northern Ireland Ambulance Service
13 February 2019

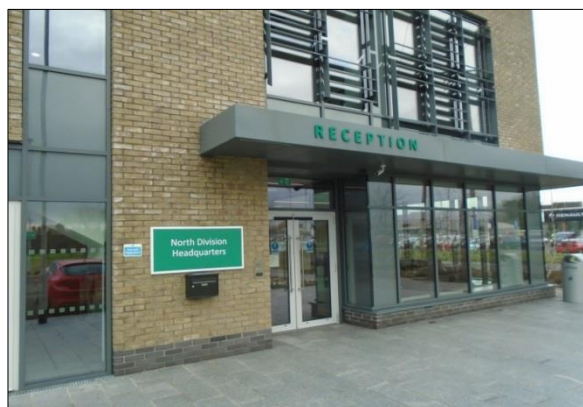
Picture 1: Ballymena Ambulance Station

On 13 February 2019, an unannounced inspection was undertaken to Ballymena Ambulance Station. Ballymena Ambulance station is a new purpose built facility, which has been operational since April 2016, to serve the population of Ballymena and surrounding areas (Picture 1).

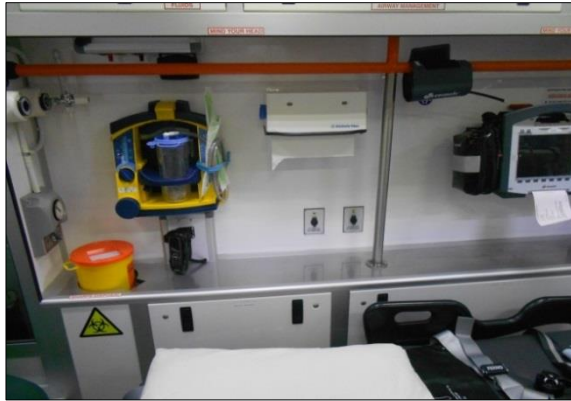
Picture 3: Clean Ambulance Surfaces and Equipment

- We inspected two emergency ambulance vehicles. We observed effective cleaning of all internal surfaces (Picture 3). The employment of vehicle cleaning operatives has had a positive effect on the standard of vehicle cleanliness. Itemised vehicle cleaning check lists/certificates are signed off on the completion of each vehicle deep clean. Station supervisors carry out routine inspections of vehicles to assure the standard of vehicle cleaning is maintained.

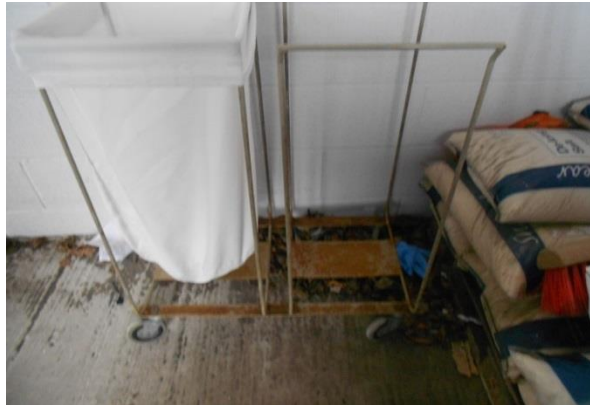
Picture 4: Rusted Linen Skip

- The used linen skip was rusted, dirty and needs to be replaced. The skip should be relocated within the dirty utility room (Picture 4).
