Investigation of *Pseudomonas aeruginosa* on biofilms in water tap assemblies from neonatal units in Northern Ireland

29th May 2012

2.0 - Final Copy

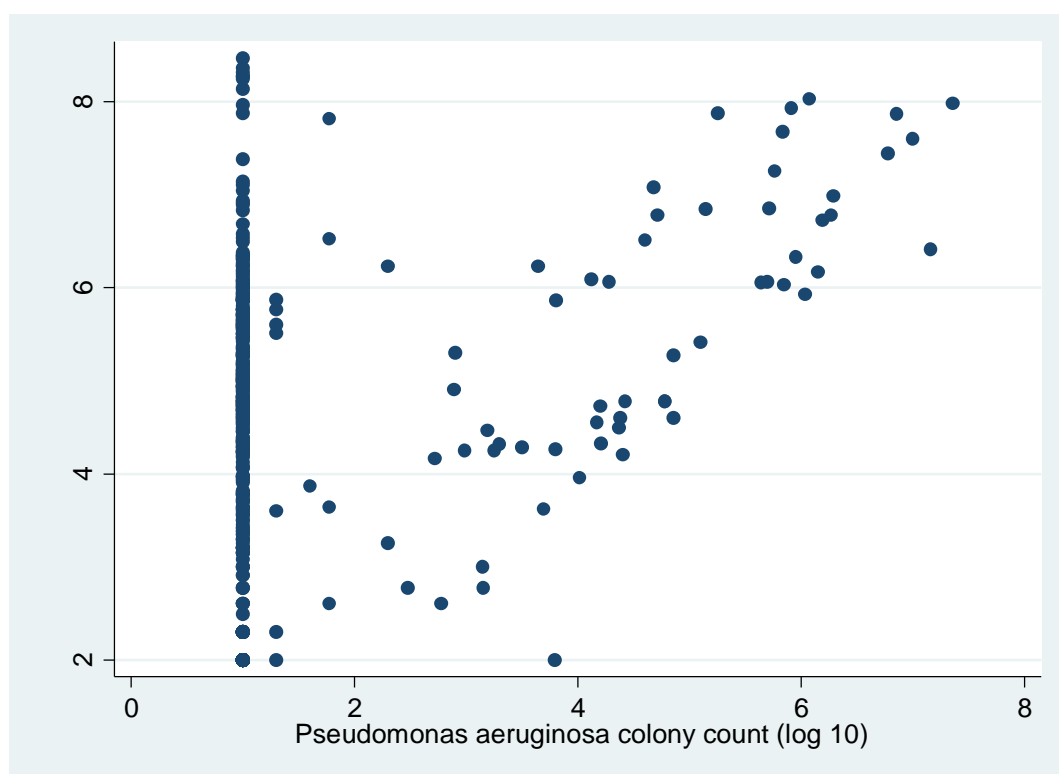
The relationship between the aerobic colony count and the presence of *P. aeruginosa* count (Figure 1) for all 494 components was analysed. The results demonstrated that many of the components that have a high aerobic colony count have no detectable *P. aeruginosa*. The correlation between the two sets of counts is weak ($r=0.33$).

Figure 1. The relationship between *Pseudomonas aeruginosa* count (CFU per component) and aerobic colony count (CFU per component).

system over time. However, it is clear from the results that there was little correlation between the aerobic colony count and the colony count of *P. aeruginosa*. Hence, from this study, it is recommended that the aerobic colony count cannot reliably be used to predict the presence or quantity of *P. aeruginosa*.

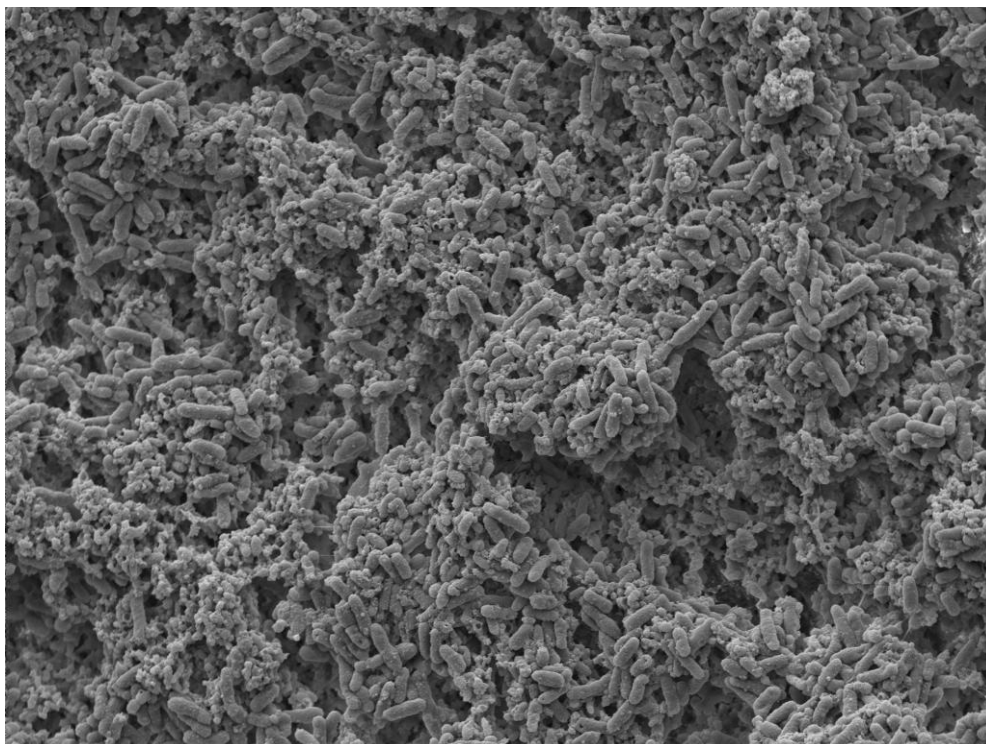
Both fluorescent microscopy and scanning electron transmission microscopy detected the presence of microbial biofilms on a number of different components (Figures 2 - 9). Confluent biofilms were observed on sections of the plastic rosettes (internal, external curvatures, flat horizontal areas, mesh grids and on the prongs) as well as on the internal and external areas of the metallic collars surrounding the rosettes. Biofilms were also observed on the organic flexible hoses but not on the cross linked polypropylene (PEX) surfaces (however, there were very limited numbers of PEX tubing samples).

Figure 2. SEM image of biofilm on plastic complex rosette (Sample No: 372284)

The presence of biofilms was extensively found on a range of rosette and tap components using fluorescence microscopy and SEM. Whilst the SEM often presented the surfaces being covered in thick layer of material in which it was difficult to observe microorganisms, the fluorescent microscopy presented this as a thick biofilm layer in which the microorganisms were clearly enmeshed.

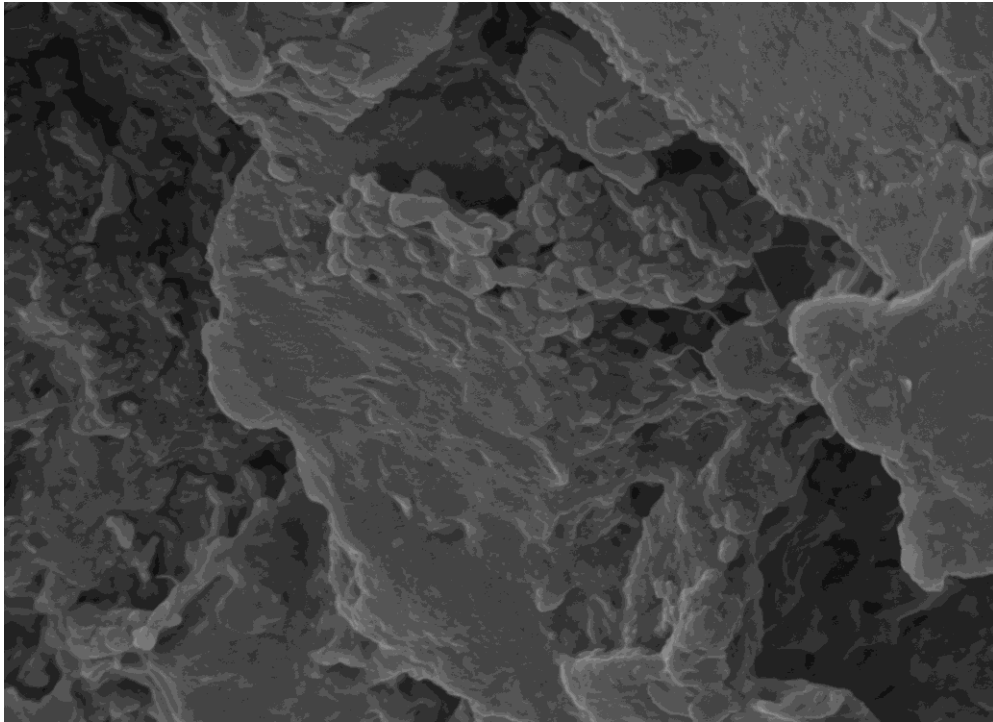
Figure 4. SEM image of biofilm on wire mesh washer (Sample No: 372367)

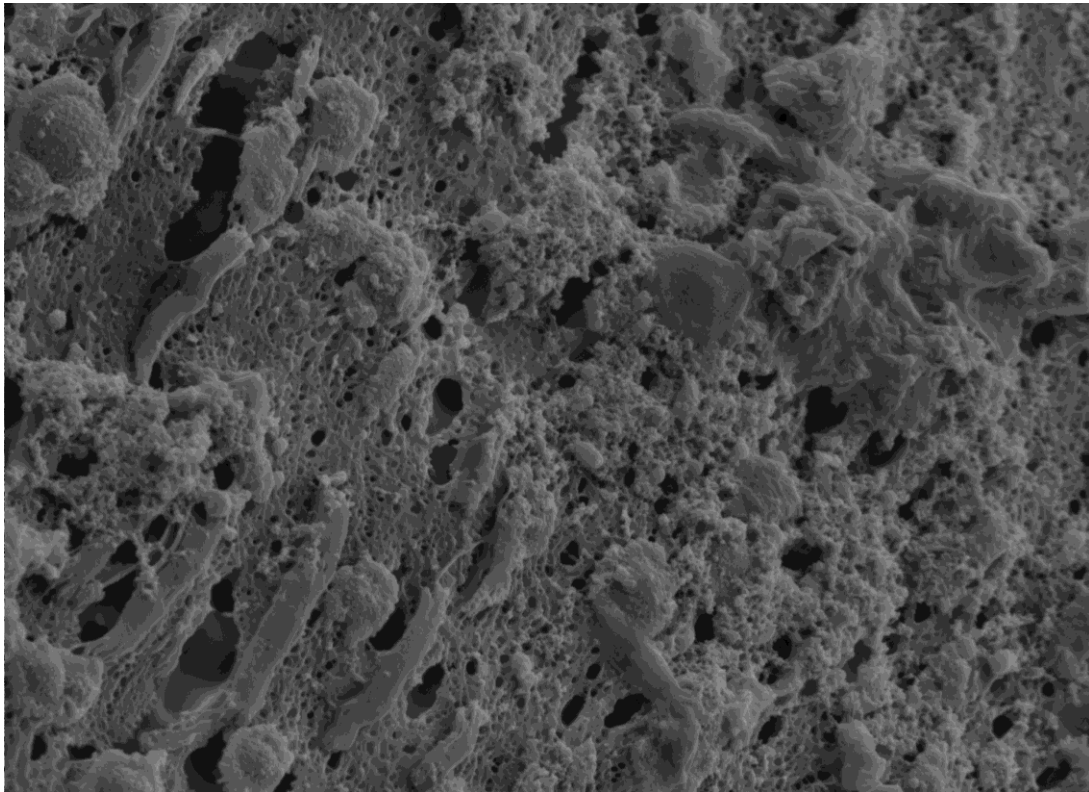
Figure 6. SEM image of biofilm on plastic rosette filter (Sample No: 372383)

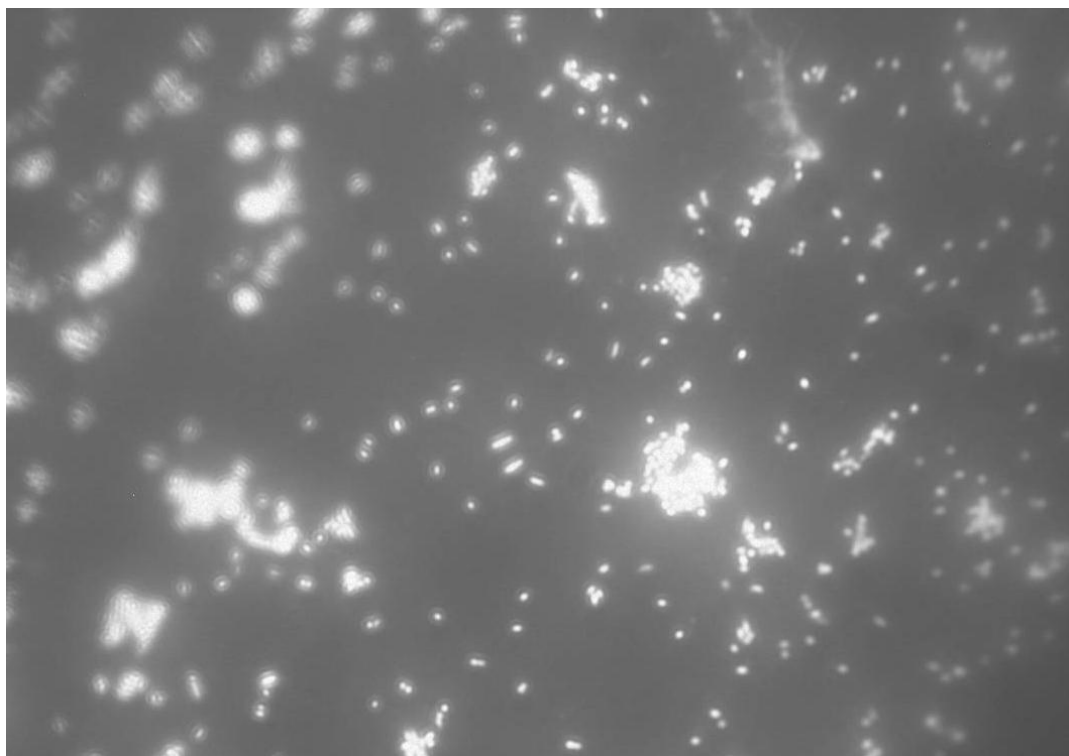
Figure 7. Fluorescent Light Microscopy image of biofilm on plastic rosette filter (Sample No: 375089)

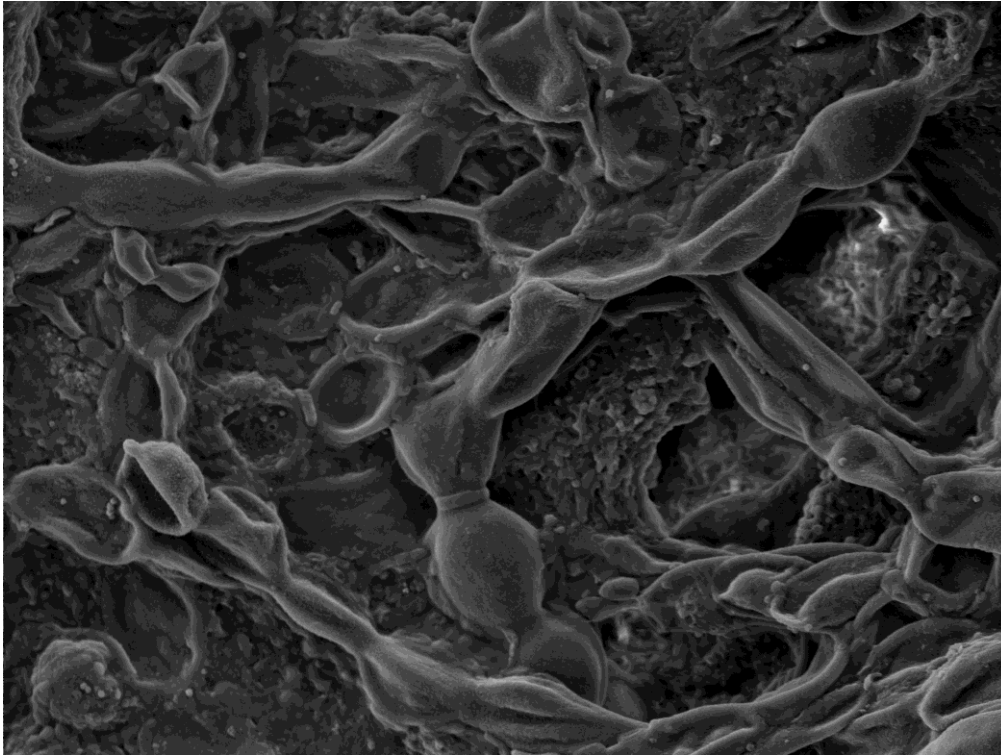
Figure 8. SEM image of biofilm on metal rosette collar (Sample No: 372381)

Where the rosettes were found to be positive, the metal collar and swabs taken from inside the tap body were also found to be positive. This would indicate that just replacing the rosette component would still leave behind a biofilm composed of *P. aeruginosa* that would contaminate the water when the tap is flowing again.

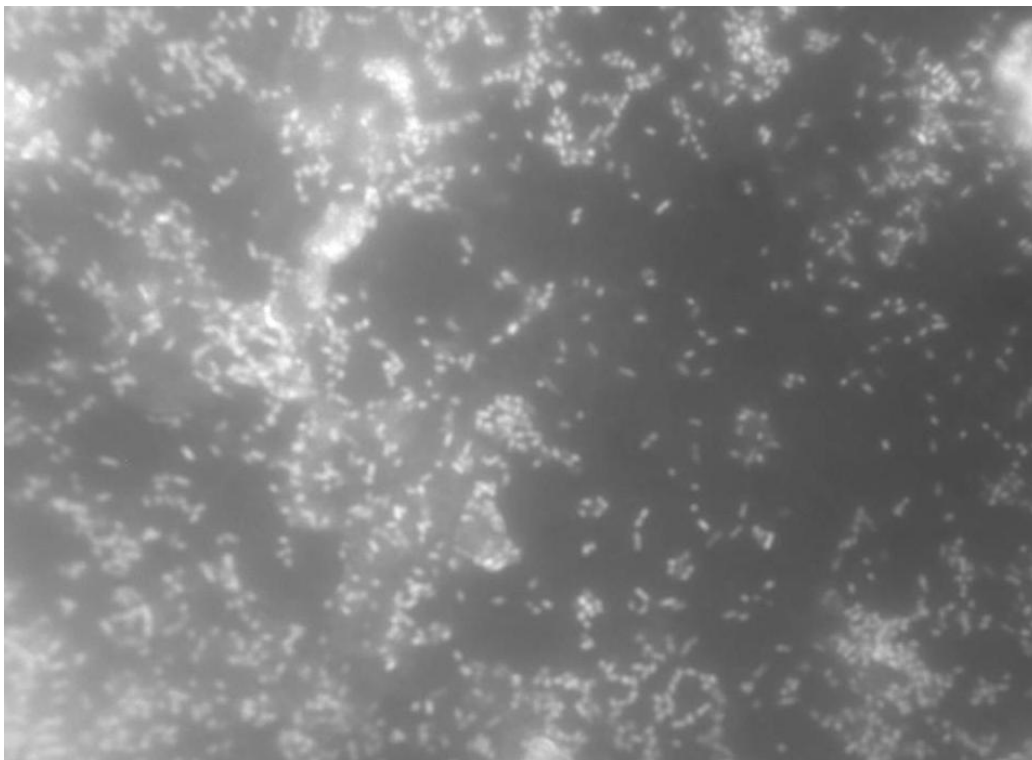
Figure 9. Fluorescent Light Microscopy image of biofilm on metal rosette collar (Sample No: 372388)

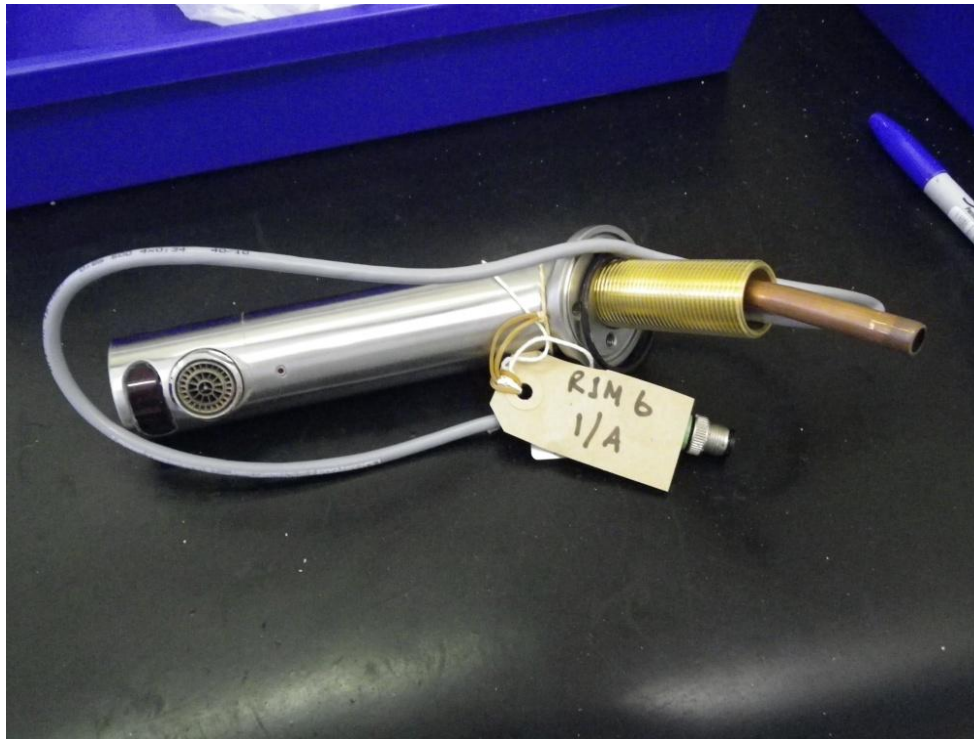
Figure 1.1. Tap assembly with plastic flow straightener in the tap spout nozzle and copper piping from The Royal Jubilee Hospital, Belfast.

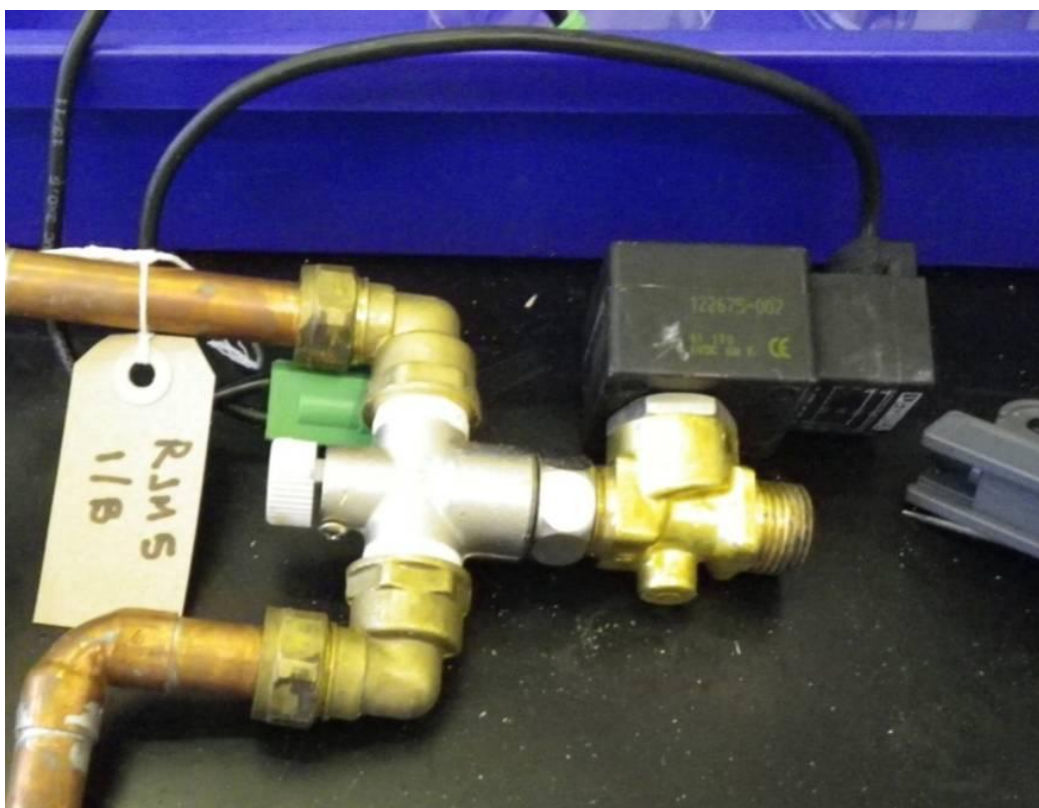
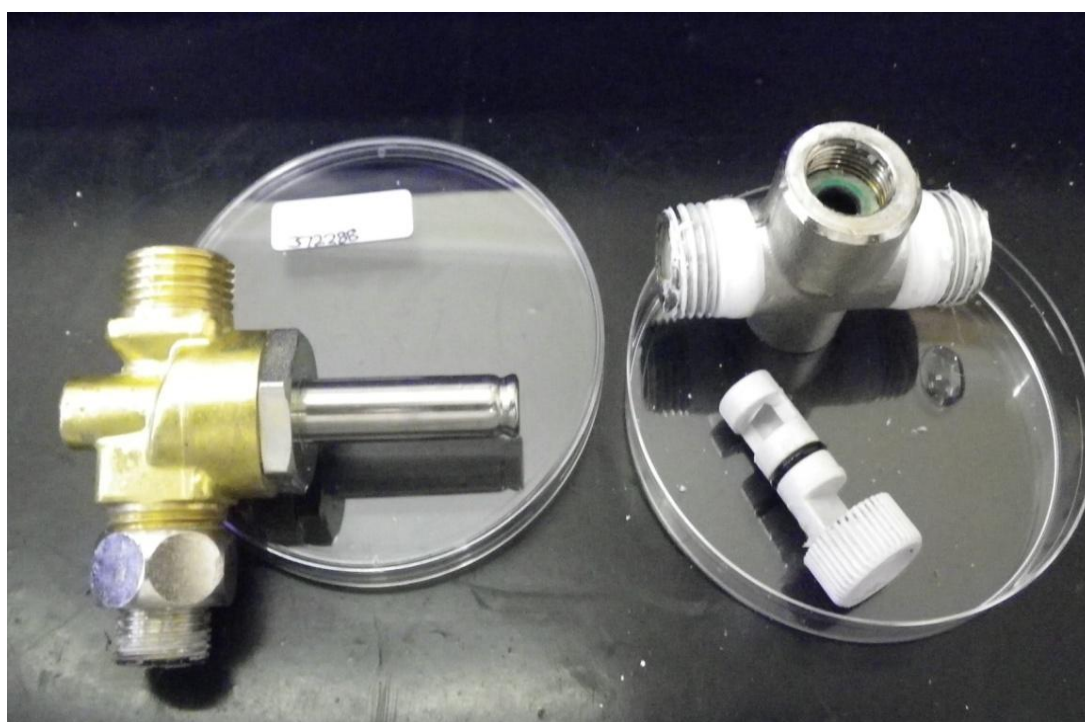
Figure 1.2 and 1.3. Integrated solenoid and blending valve from The Royal Jubilee Hospital, Belfast.

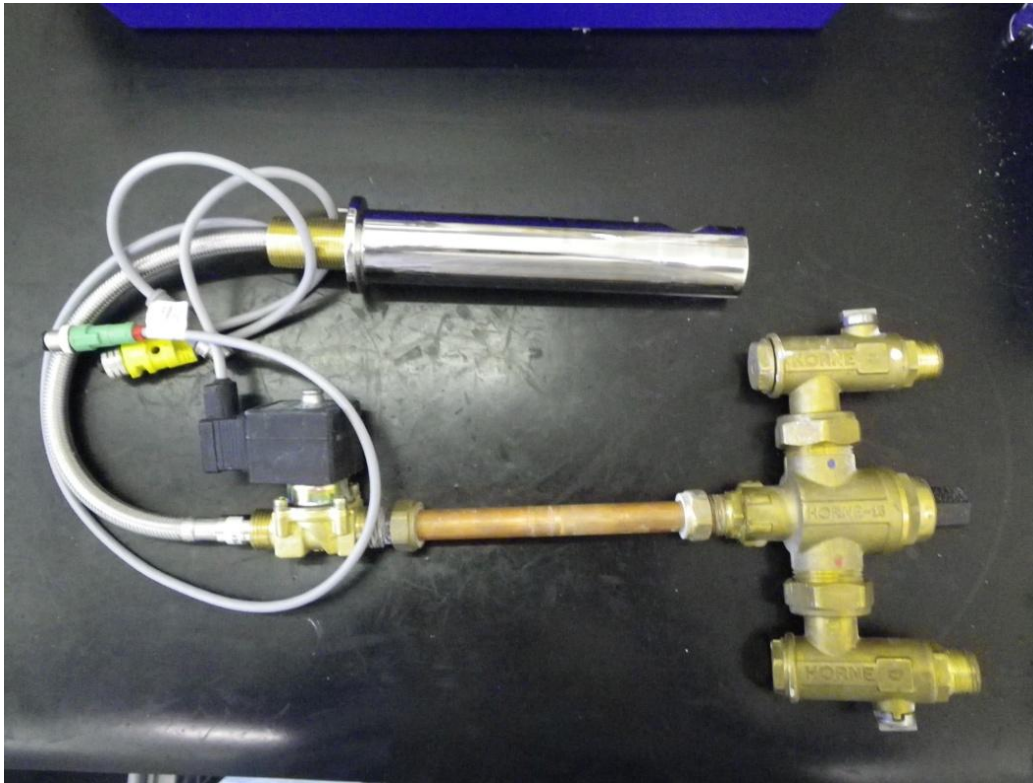
Figure 2.1. Tap assembly and components with flexible hoses from Ulster Hospital, Dundonald.

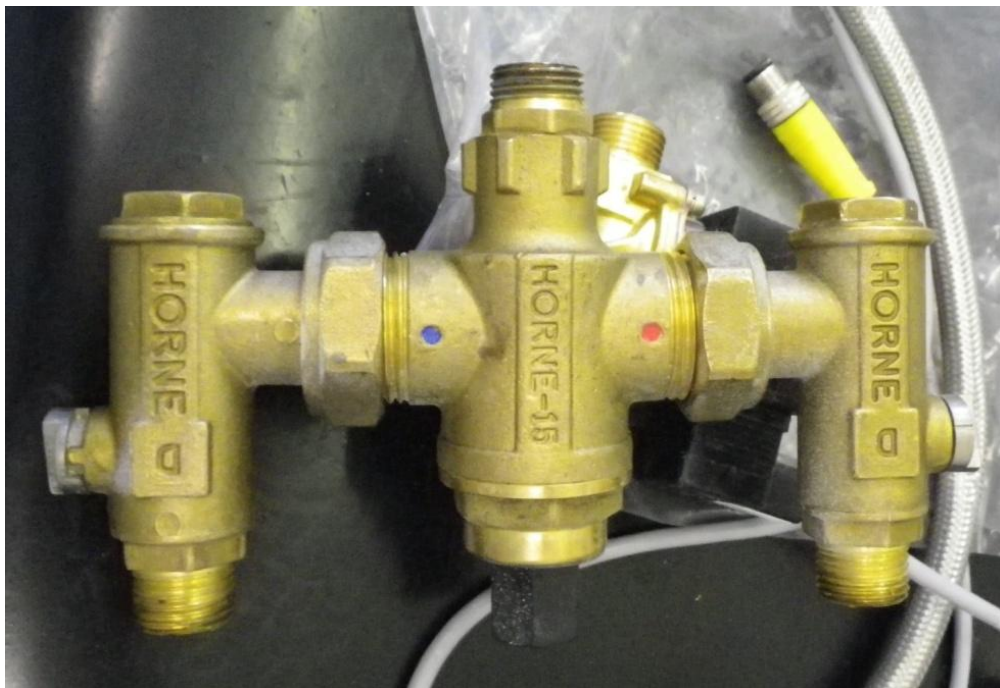
Unlike The Royal Jubilee Hospital, however, the associated solenoid and thermal mixer valve were not integrated and were of a different manufacture. This thermal mixer contained isolation valves on each side of a large central mixing chamber (Figure 2.2).

Figure 2.2. Solenoid and thermal mixing valve from Ulster Hospital, Dundonald.

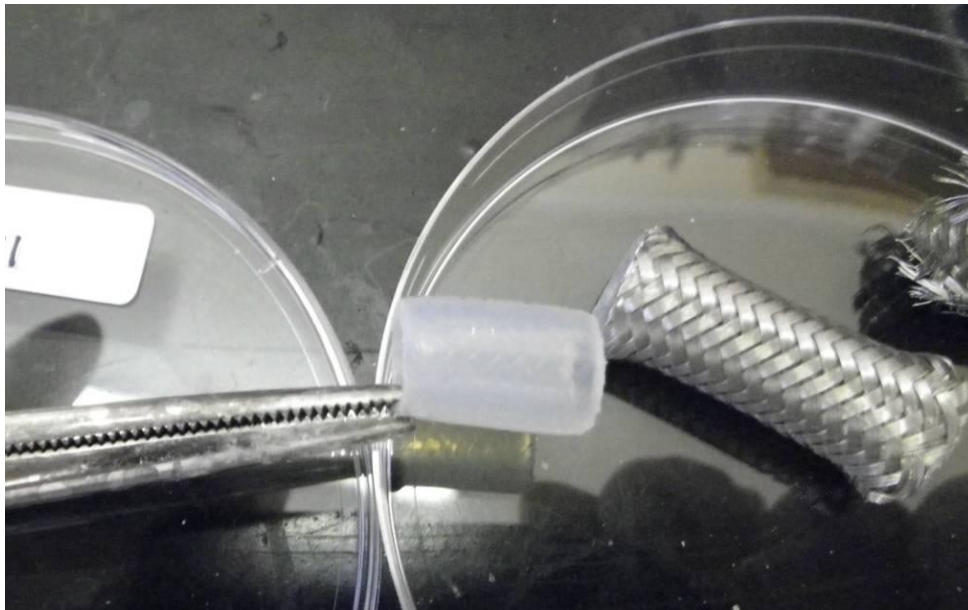
Ethylene Propylene Diene Monomer flexi-hoses were used to connect the tap unit to the solenoid unit instead of copper pipe (Figure 2.3). Two makes of EPDM inner hose were used, black and clear.

Figure 2.3. Flexi tubing connection tap to solenoid from Ulster Hospital, Dundonald

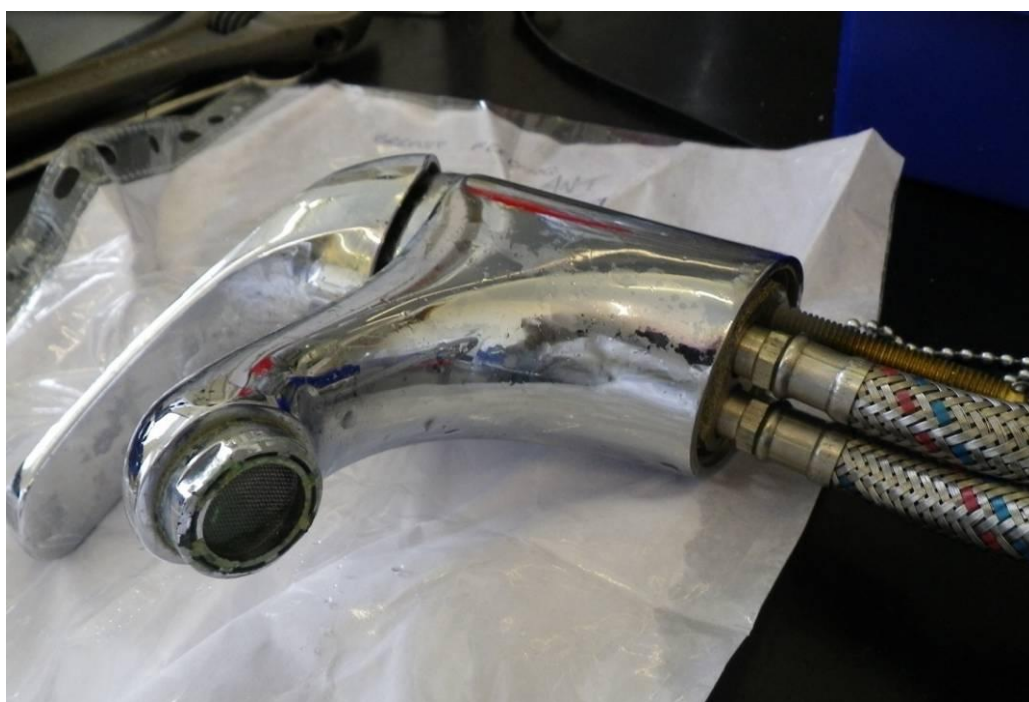
Figure 4.1. Taps manufactured by U/K from Antrim Area Hospital, Antrim

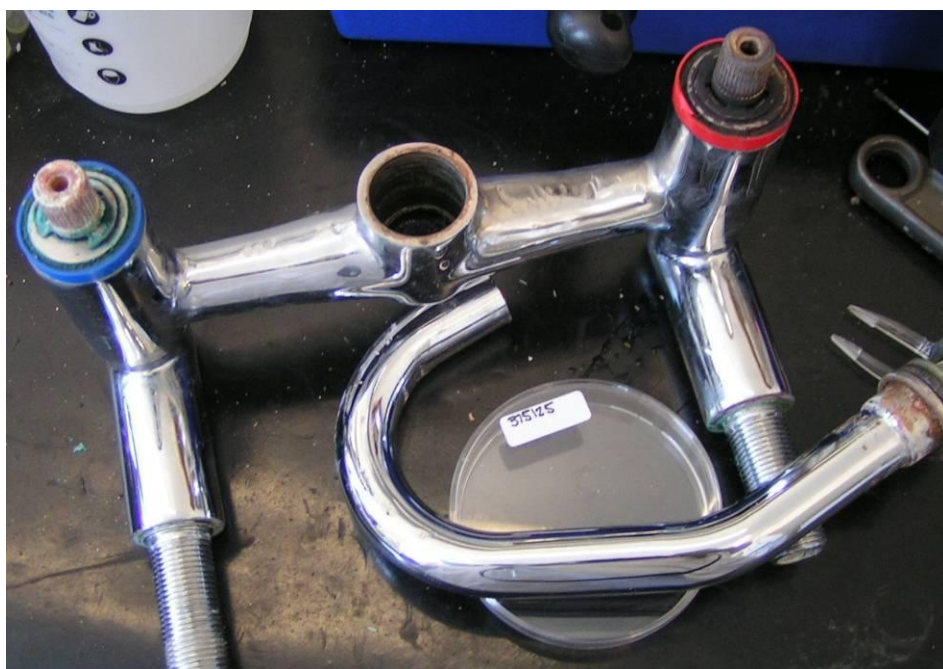
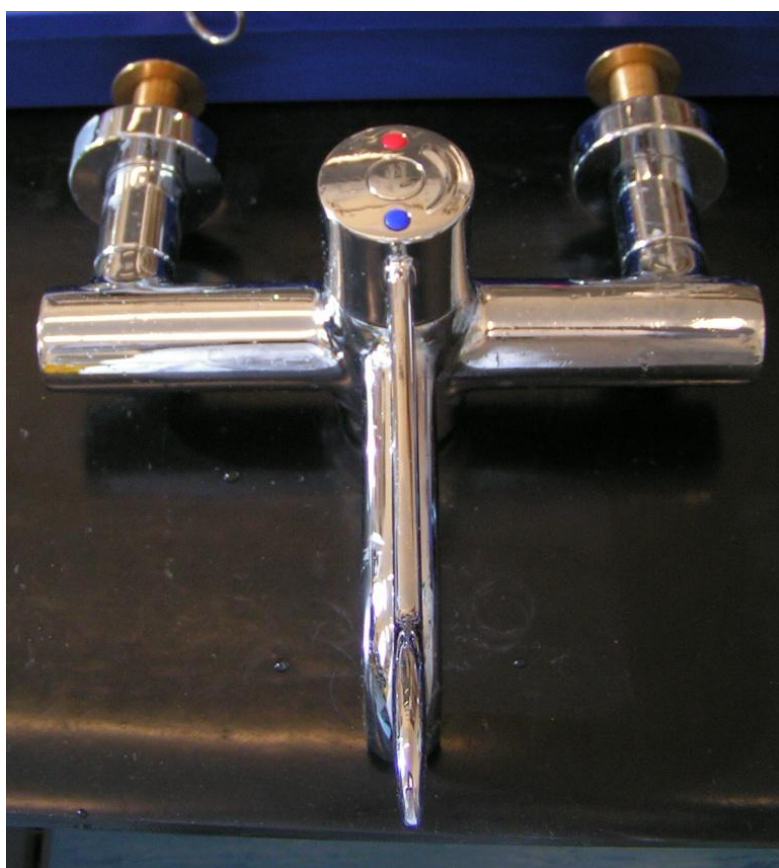
The other three U/K manufactured taps followed a traditional swan neck and lever design (Figure 4.2). These taps contained rosette type D roses (Appendix 8).

The one tap manufactured by Armitage shanks was a monoblock design (Figure 4.3 and contained rosette type C rose (Appendix 8).

Figures 4.2 & 4.3. Taps manufactured by Armitage Shanks from Antrim Area Hospital, Antrim

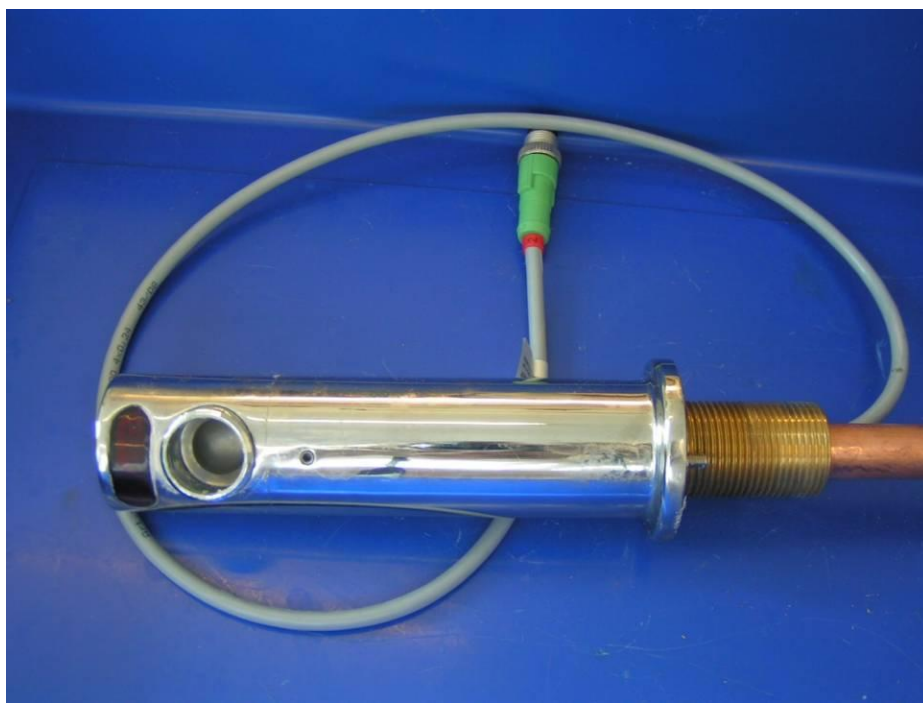
On the 24th of February, 2012, one tap assembly was received by HPA Porton. The tap assembly was only accompanied by the solenoid unit and did not contain other components such as the rosette centre piece (Figure 4.4).

Figure 4.4. Tap from Daisy Hill Hospital, Newry

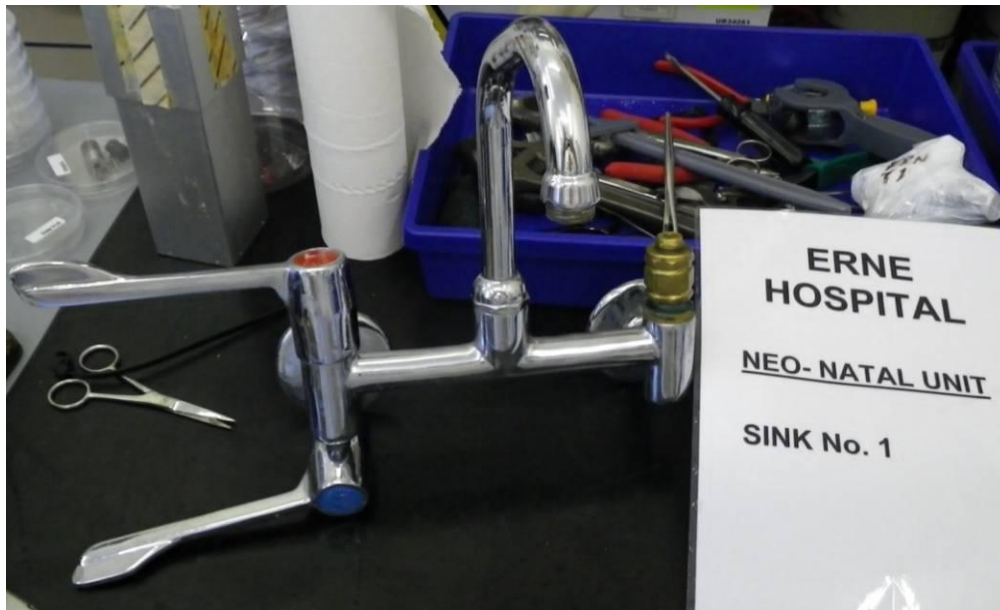
On the 24th of February, 2012, one swan neck and lever style tap assembly (Figure 5.1), five rosettes (Figure 5.2) and one thermal mixer (Figure 5.3) were received by HPA Porton.

Figure 5.1. Tap from Erne Hospital, Enniskillen

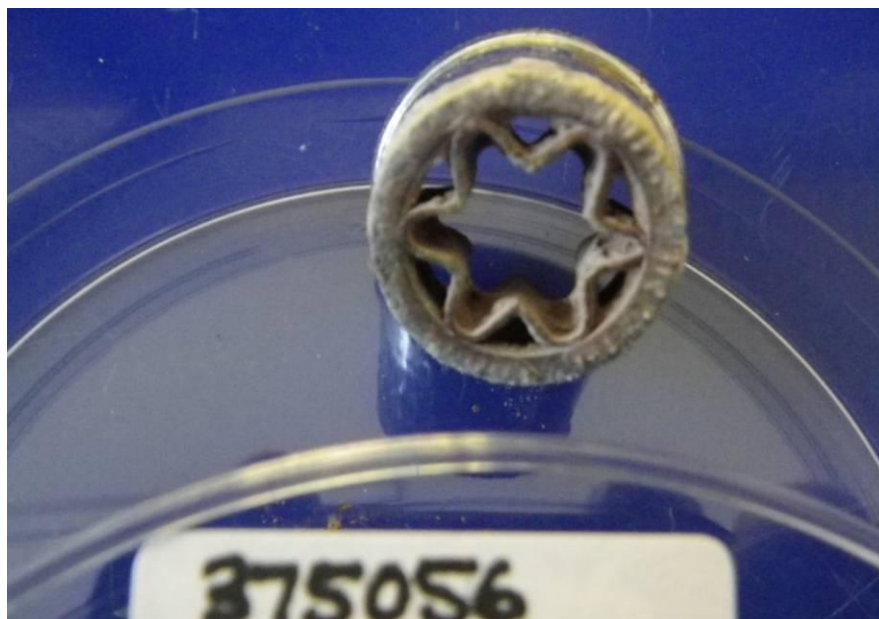
The five rosettes were categorised as type F rosettes (Appendix 8)

Figure 5.2. Flow straighten piece from Erne Hospital, Enniskillen

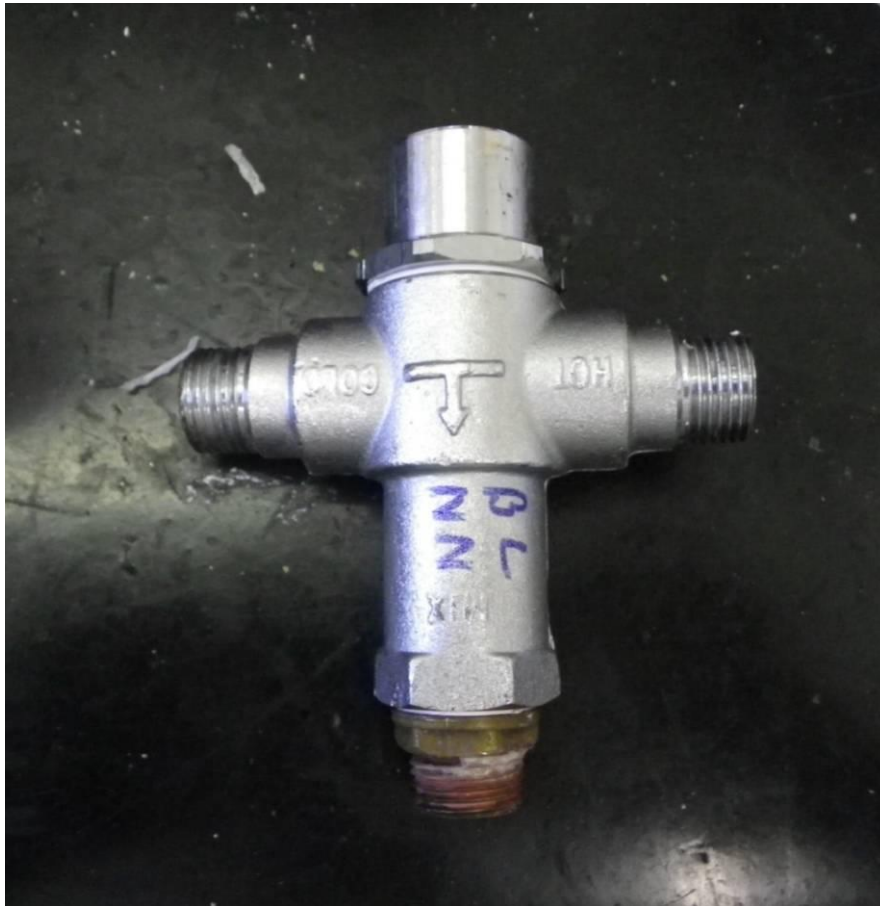
Figure 5.3. Thermal mixer from Erne Hospital, Enniskillen

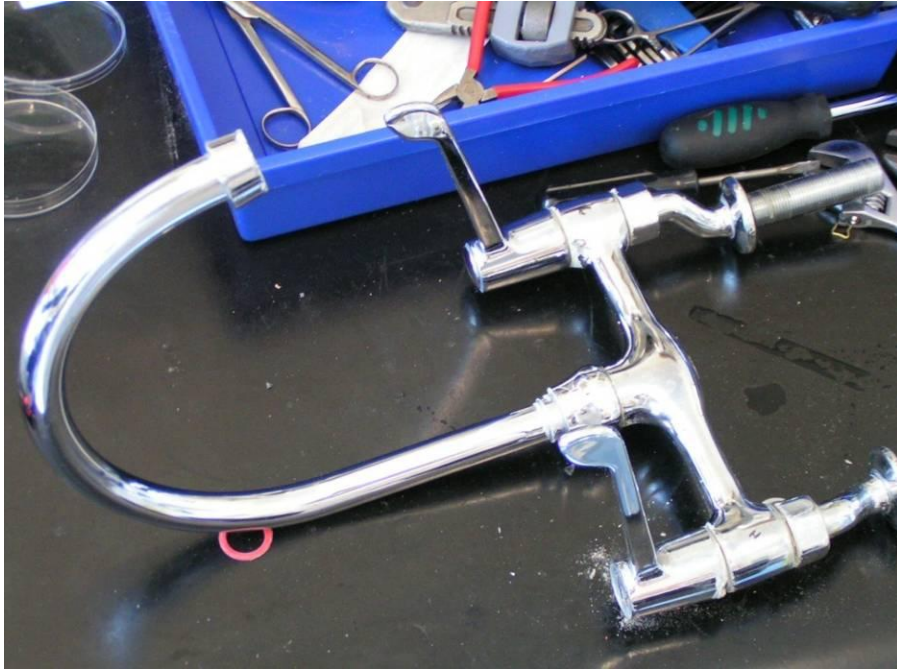
On the 17th of February two swan neck and lever style tap assemblies were received by HPA Porton (Figure 6.1). The tap unit was broken down into 12 samples to be examined by microbiology and also microscopy.

Figure 6.1. Tap from Craigavon Area Hospital, Craigavon

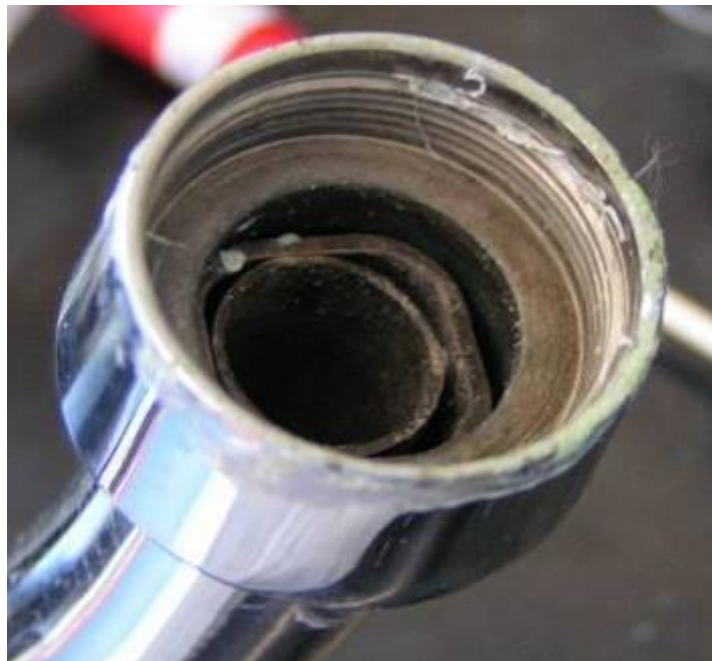
The tap outlets contained a washer, screw grooves and had traces of tape or glue, suggesting the presence of a flow straightener which had not been supplied for analysis (Figure 6.2).

Figure 6.2. Image of tap outlet from Craigavon Area Hospital, Craigavon

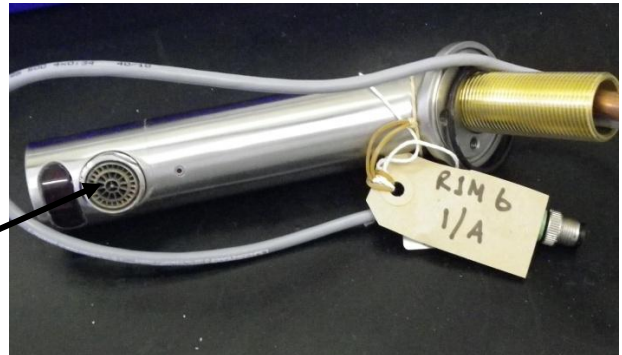
Sensor Tap – These taps use built in infrared sensors to control the solenoid valve, which then releases the water at a standard heat and flow rate.

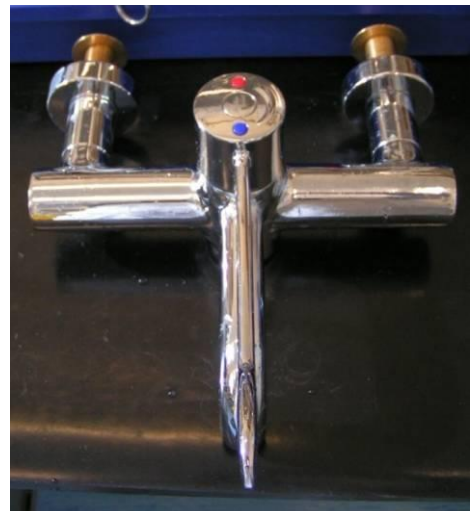
Mono bloc mixer taps – Mono bloc mixer taps work by adjustment of a single lever which dually controls both cold and hot water flow. This then flows into a central mixing chamber before reaching the tap outlet. Two mono bloc mixer taps units were supplied by Northern Ireland

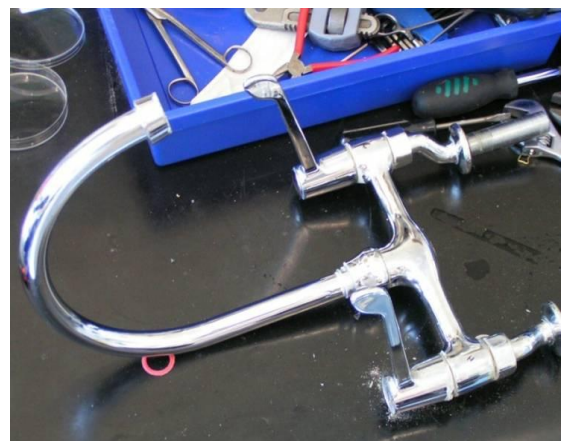
Traditional bridge mixer tap - These taps control flow and temperature through manually adjusting corresponding levers. This action changes the position of internal tap valve mechanisms (which act in place of the solenoid) and the hot and cold water are mixed in the “bridge” or in tap outlet.

There were 6 traditional bridge mixer taps with twin lever design and swan neck style tap units supplied by Northern Ireland.

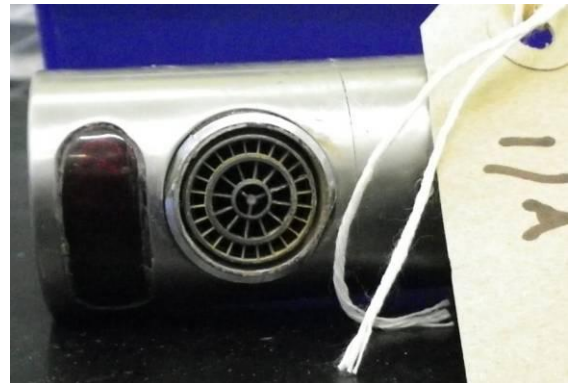
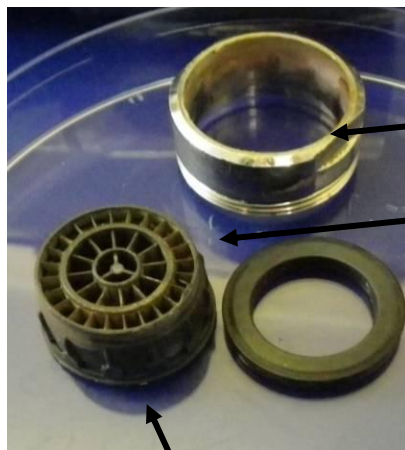
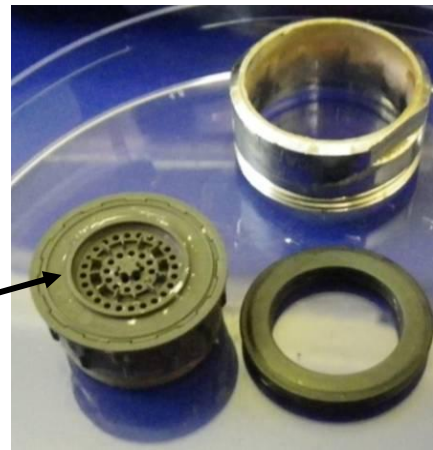
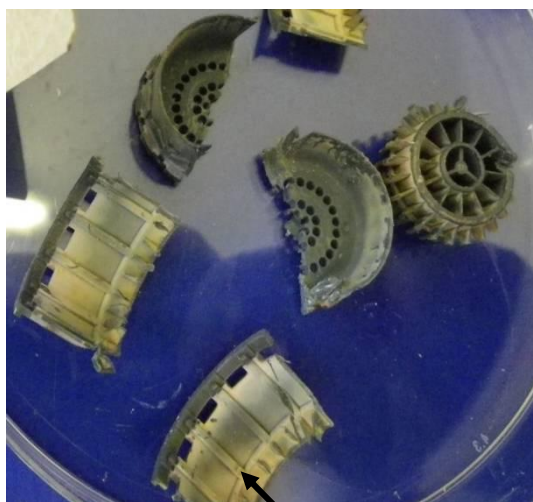
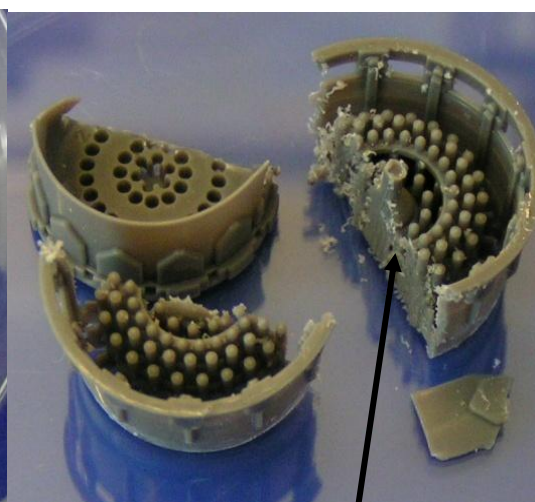
Rosette / Flow straightener or aerator – A single component which sits at the end of the tap outlet. This is a complex structure comprising of many surfaces, see pictures below.

**Plastic villi shapes
which sit behind
outward face**

As the tap outlets are supplied with water from a thermostatic mixer valve (TMV) at approximately 42°C then there will be no thermal control of the microorganisms downstream of the TMV. As such, each time that the tap is operated, the biofilm on the rosette components in the tap body will be replenished with freshly oxygenated water, containing a supply of nutrients that will encourage further biofilm growth on the rosette. The rosette itself will present a large surface area to volume ratio and will also retain water in dead spaces thereby creating a moist stagnant environment (between plastic rosette and metal collar, Appendix 7) in which the biofilm will grow.

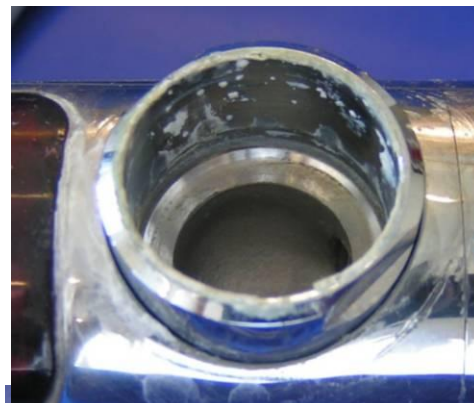
Rosette / Flow straightener metal collar – Screws into tap body and holds the Rosette piece in place

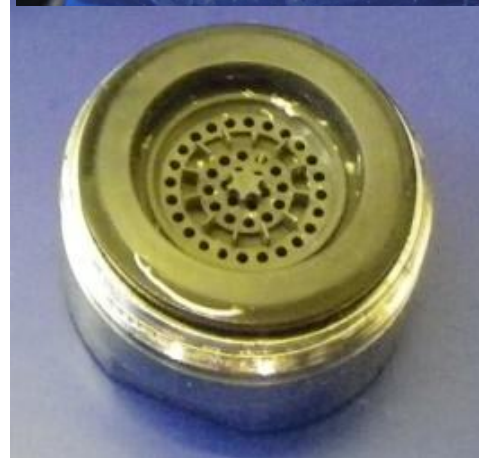
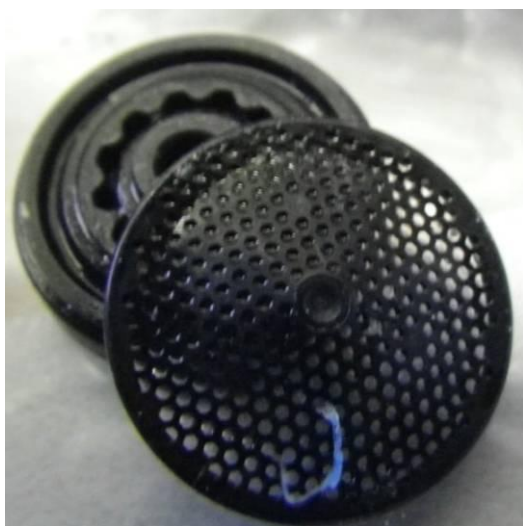
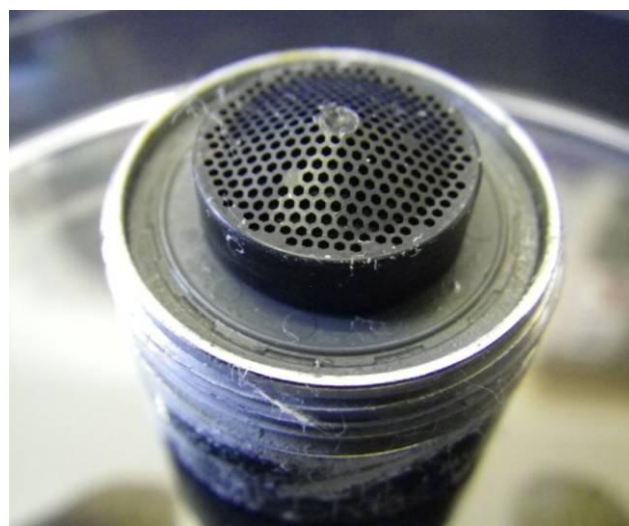
Rosette / Flow straightener washer – This sits on the inward face and is moulded into the rosette component and around the filter piece.

Rosette / Flow straightener filter – This sits on the inward face and is moulded into the rosette component.

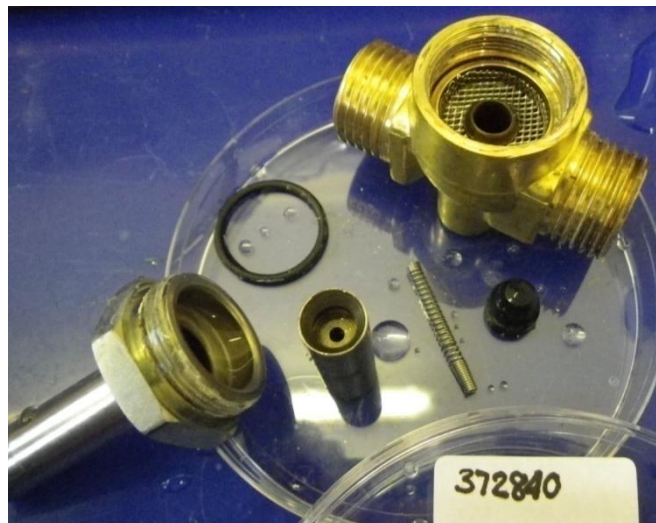
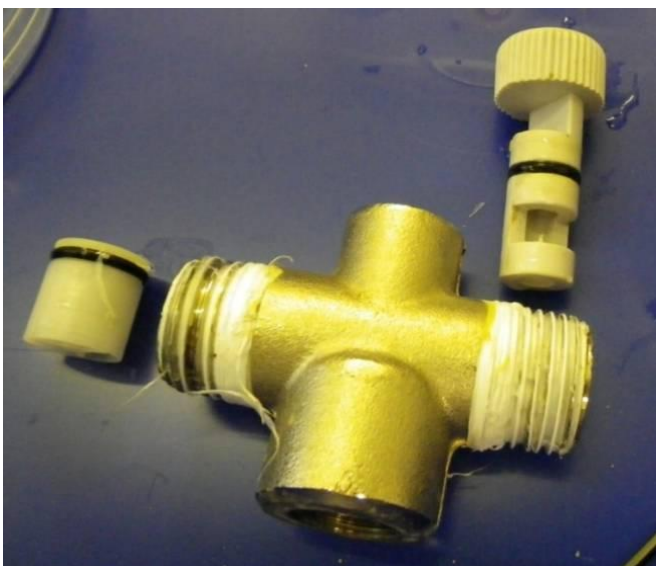
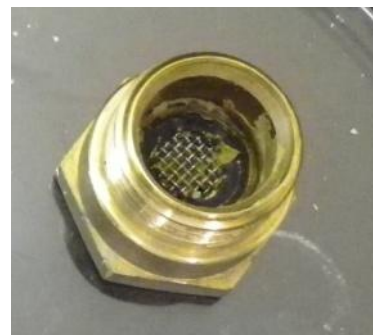
Bender valve - Controls the temperature of the water by presetting the temperature by varying input of cold and hot supply feeds.

The valves supplied by The Royal Jubilee Hospital, Belfast contained washers with coarse wire mesh inbuilt to cold and hot water pipe connectors to filter large debris before entering mixer. This mixer also had one way valves placed at the hot and cold inlet to prevent backflow. This was a simplistic design and a central plastic temperature control valve controlled the cold and hot water feeds.

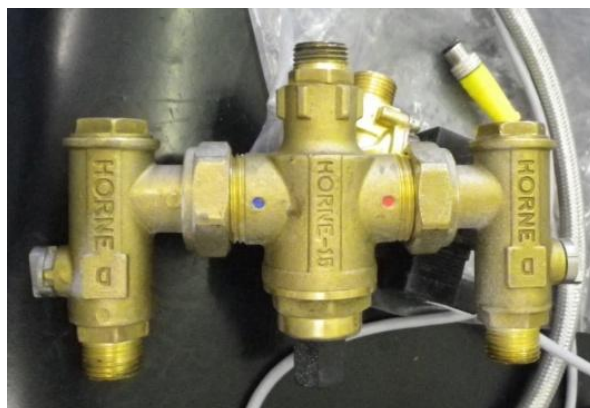
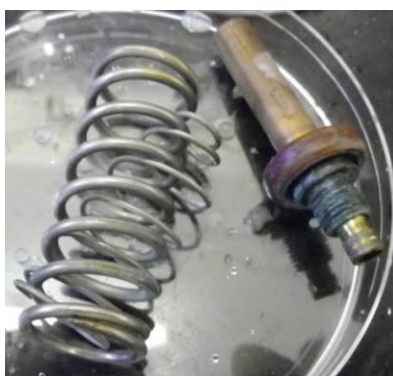
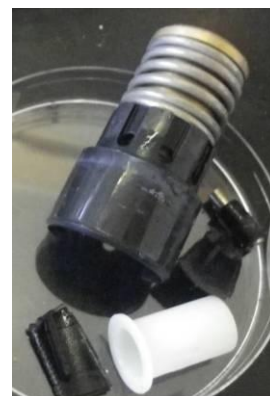
Thermostatic mixer valves - The thermal mixers supplied by Ulster Hospital, Dundonald were much larger and more complex. Cold and hot water supplies were fed into chambers lined with a fine wire mesh. These chambers housed individual isolation valves to cut off each feed.

These hot and cold chambers then feed into a central chamber with a complex temperature control valve comprising of plastic and metal components.

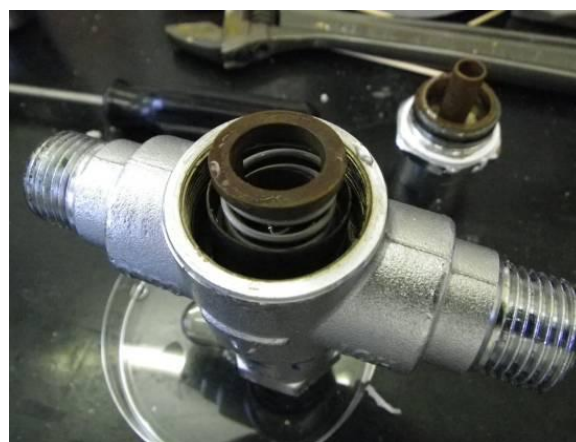
The thermal mixer taken from Erne Hospital, Enniskillen also contained one way valves at the hot and cold inlet to prevent backflow. The temperature control valve was a complex metal component fixed inside the main chamber.
