Investigation of *Pseudomonas aeruginosa* on biofilms in water tap assemblies from neonatal units in Northern Ireland

29th May 2012

2.0 - Final Copy

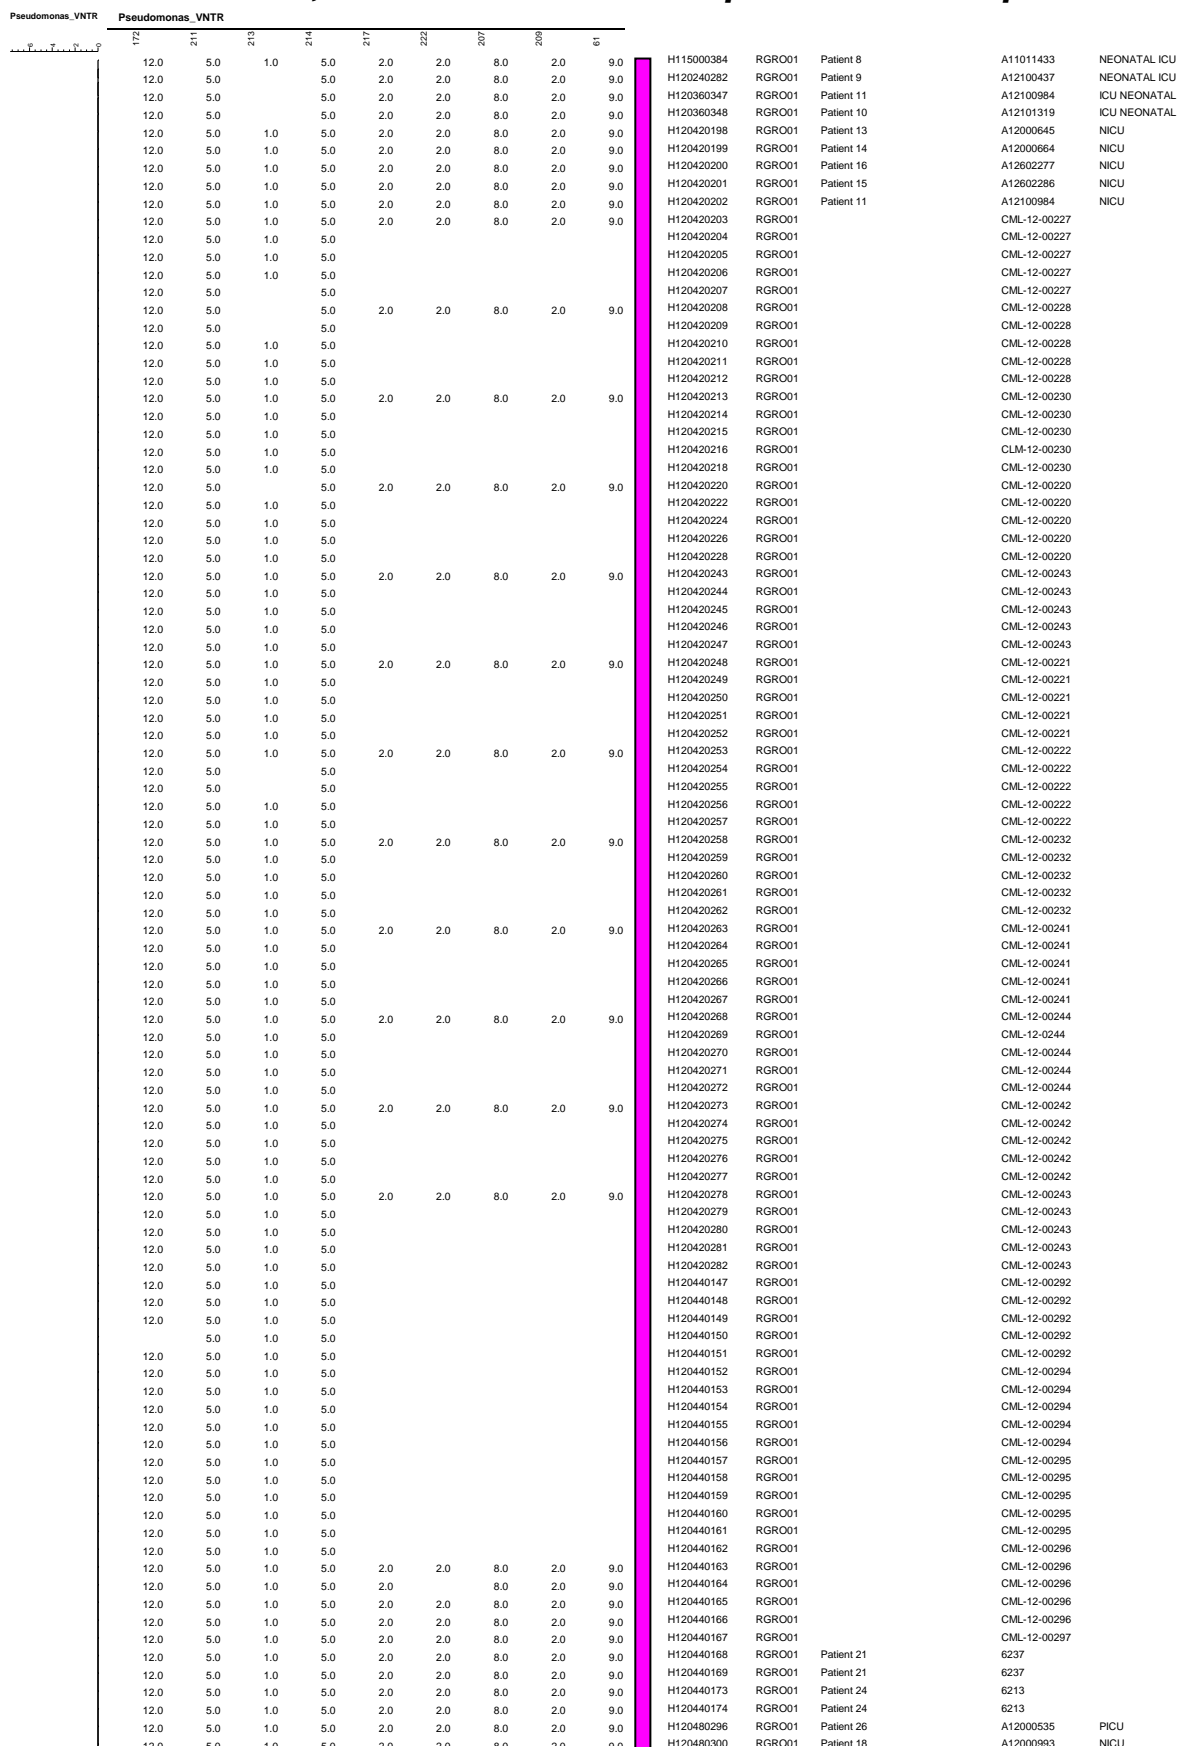
Appendix 9: Dendrogram of isolates from neonatal unit patients with environmental, water and biofilm samples from the tap outlets.

Representative isolates recovered from tap assemblies from Belfast (Royal Jubilee Maternity) and Altnagelvin hospital neonatal units were analysed by the VNTR method and found to be consistent with strains recovered from the water samples and from the infected patients (strains 2 and 4). One other strain matched only to the water isolates.
