# Unannounced Infection Prevention/ Hygiene Inspection Report

5 July 2017

# Broadway Ambulance Station Northern Ireland Ambulance Service

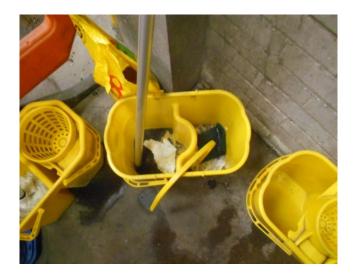
- Cleaning disinfectants were not stored in line with control of substances hazardous to health (COSHH) Guidance. Tubs of detergent and alcohol wipes in the ambulance vehicles were open, and cloths were protruding and dry.
- Cleaning equipment located within the domestic and ambulance sluice areas (in the main garage) was dirty and in poor repair (Picture 2). Cleaning items included brushes and shafts, mops wringers and buckets, which contained dirty stagnant water. Using this cleaning equipment on other areas of the station presents a significant risk of cross contamination.

Picture 2: Dirty ambulance cleaning equipment
